Intel® Pentium® 4 Processor

Specification Update

August 2003

Document Number: 249199-040

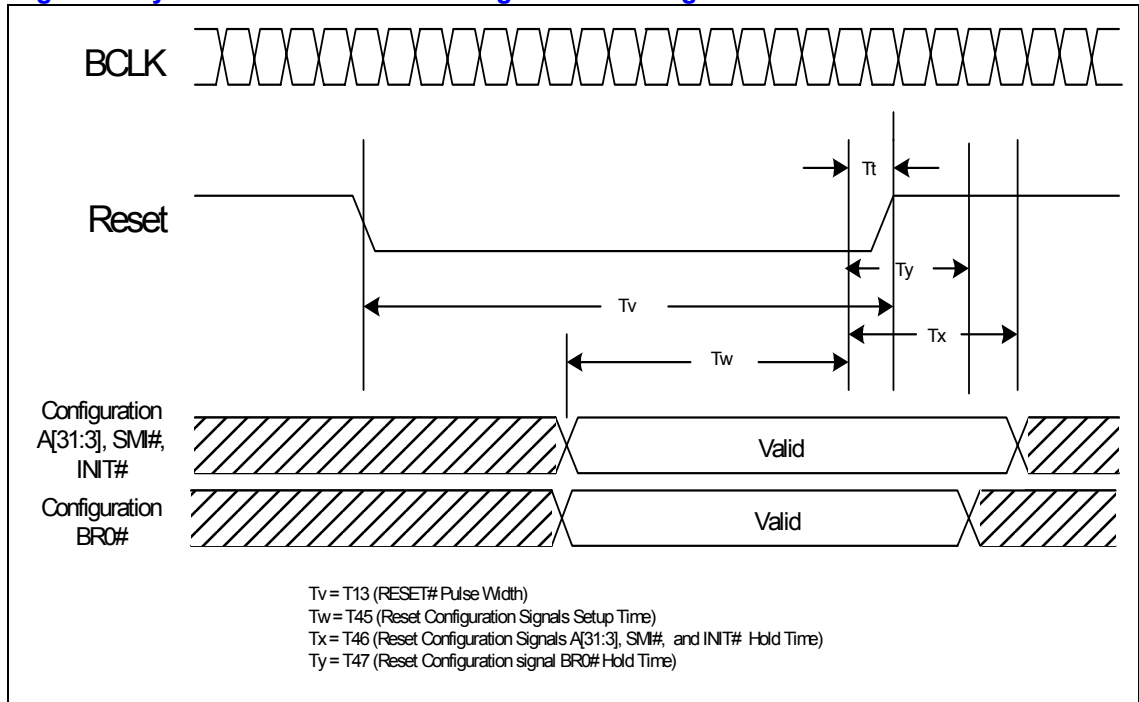
Figure System Bus Reset and Configuration Timings

The BR0# maximum hold time has changed to 2 BCLKs. This change will be shown in the “System Bus AC Specifications (Reset Conditions)” table and “System Bus Reset and Configuration Timings” figure of the Intel(R) Pentium(R) 4 Processor with 512KB L2 Cache on 0.13 Micron Process EMTS & Intel(R) Pentium(R) 4 Processor in the 478-pin Package Electrical, Mechanical, and Thermal Specifications (EMTS) & Intel(R) Pentium(R) 4 Processor in the 423-pin Package Electrical, Mechanical, and Thermal Specifications (EMTS). These changes will be incorporated in the next revision of the EMTS (Datasheet).
